Phase I Environmental Site Assessment

Tropicana Parcels – 13th Avenue @ 6th Street East
409, 413, 417 13th Avenue E and 516 12th Avenue Dr. E
Bradenton, Manatee County, Florida
Parcel ID Nos. 4618800009, 4618700001, 4618600003, and
4591300001

Conducted Under
EPA Cooperative Agreement No. BF-95481811-0

July 2013

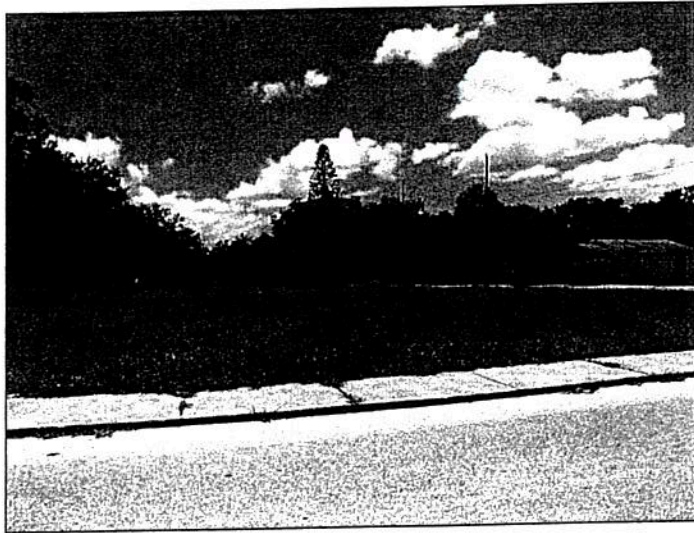
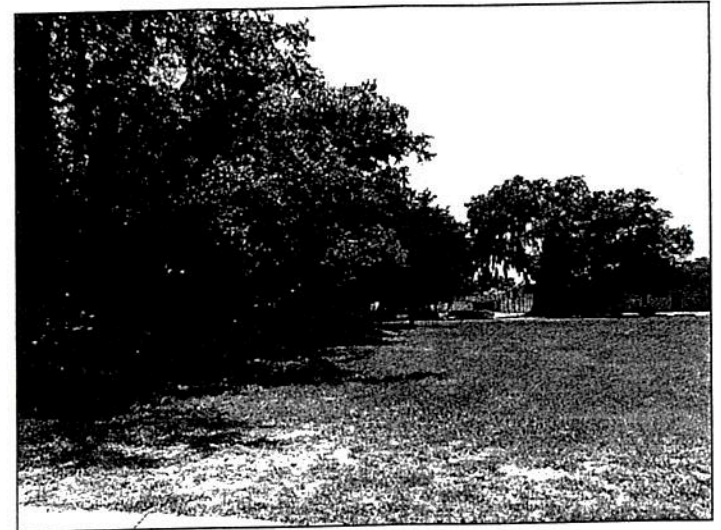
Left and Right: Typical views of the subject site.

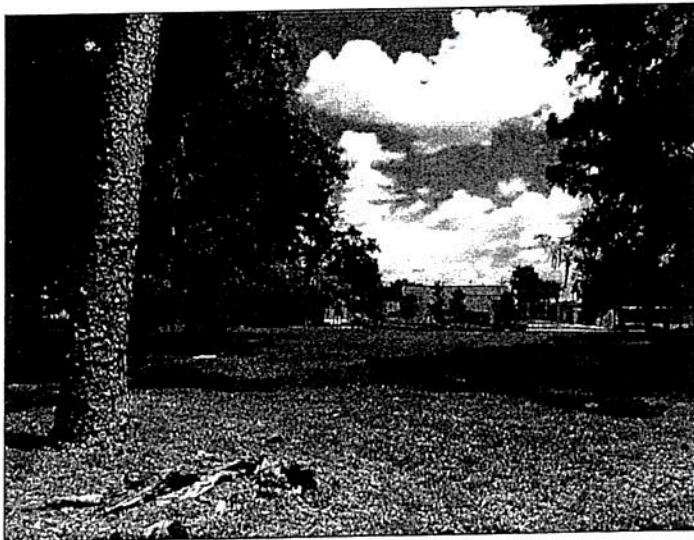
Left: View looking across the subject site from 6th Street.

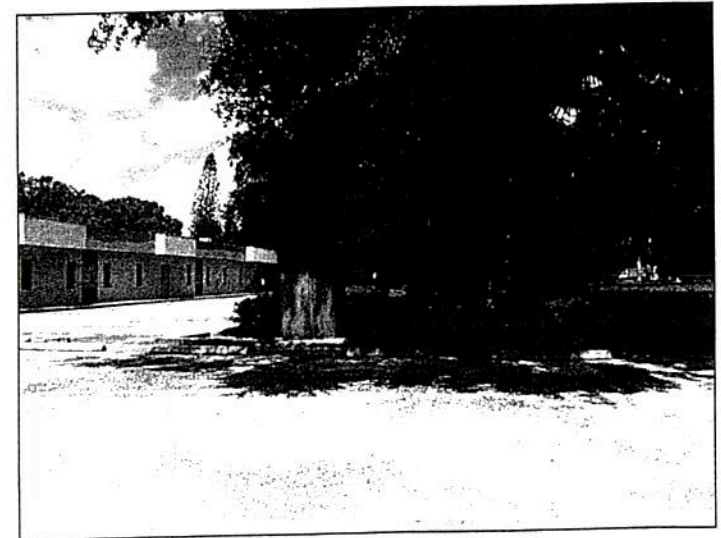
Right: View of adjacent family services and associated pad-mounted transformer.
